**TRANSPORTATION SCIENCES CENTER
ACCIDENT RESEARCH GROUP**

**CALSPAN ON-SITE AIR BAG DEPLOYMENT INVESTIGATION
CALSPAN CASE NO. 95-2
VEHICLE: 1994 FORD F-150 PICKUP TRUCK
LOCATION: [REDACTED] MS
CRASH DATE: [REDACTED] 1994**

SUMMARY

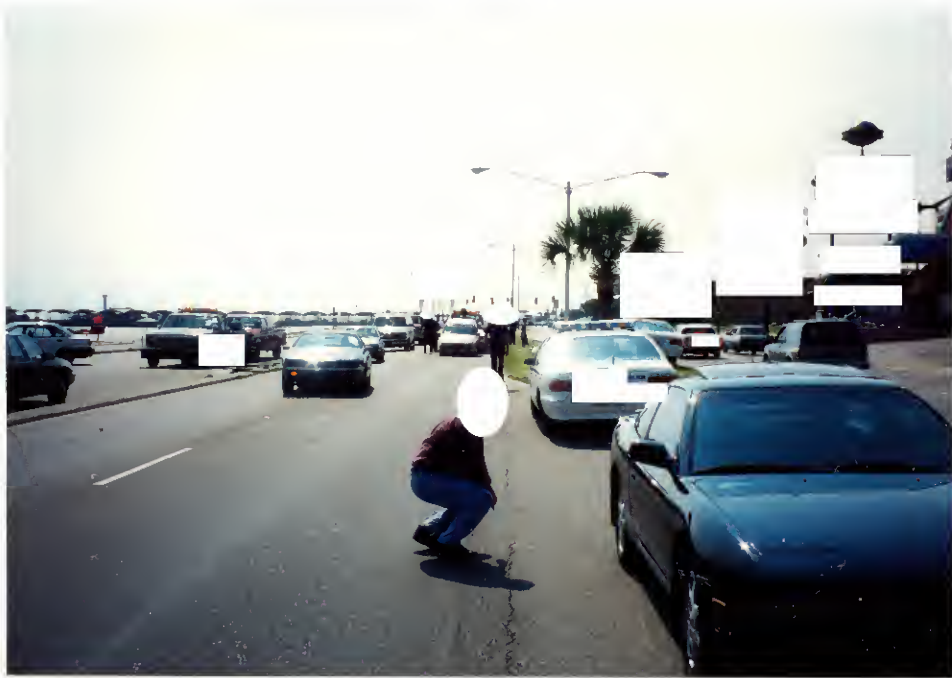
1. Lookback view of the crash site.

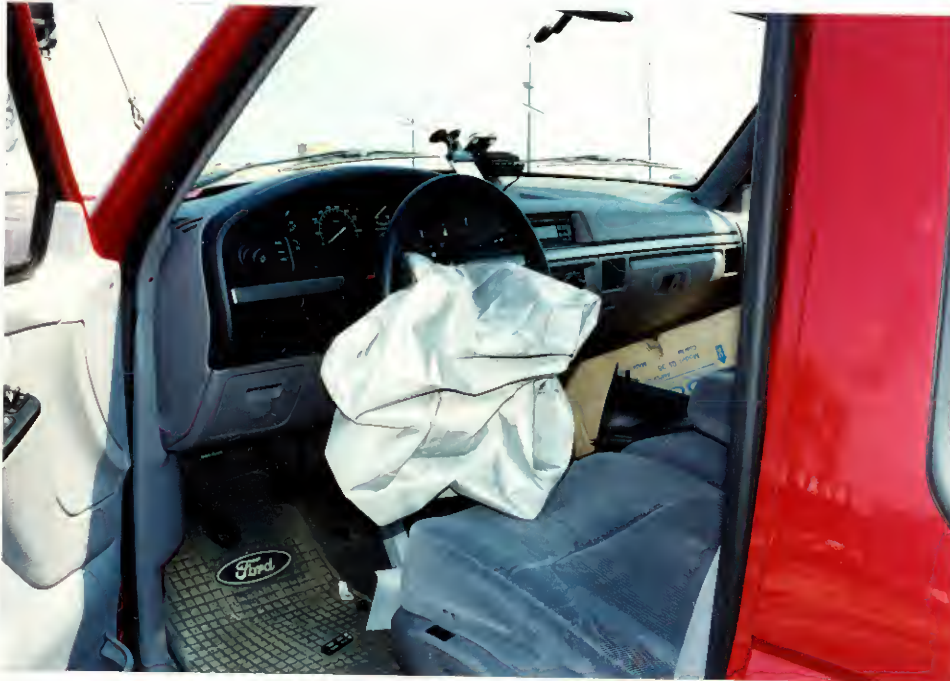
3. Overall view of the Ford's interior and the deployed driver's side air bag.

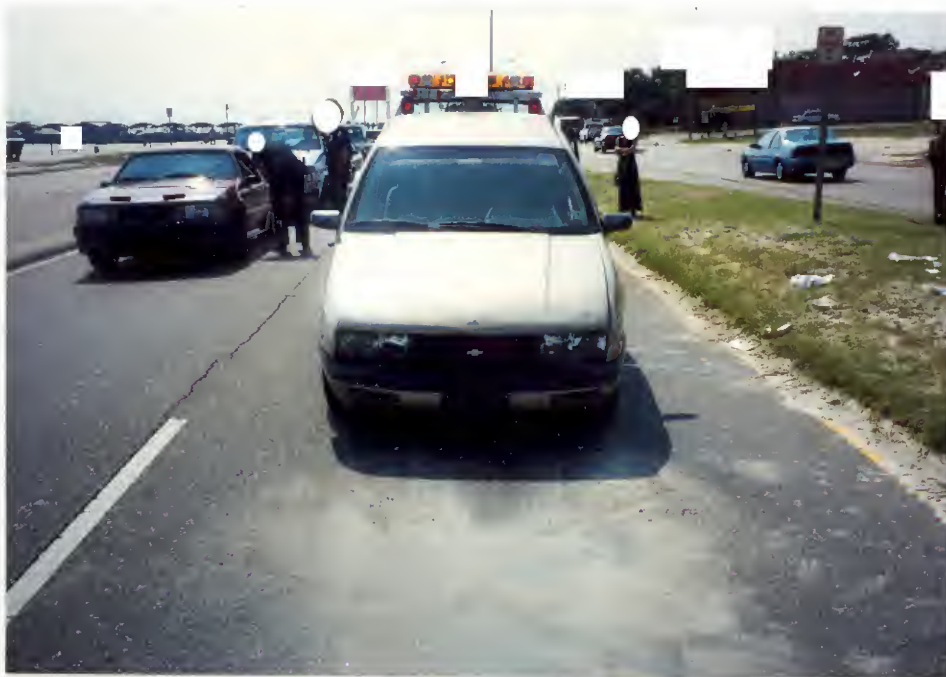
7. Approximate final rest position of the Chevrolet Corsica.

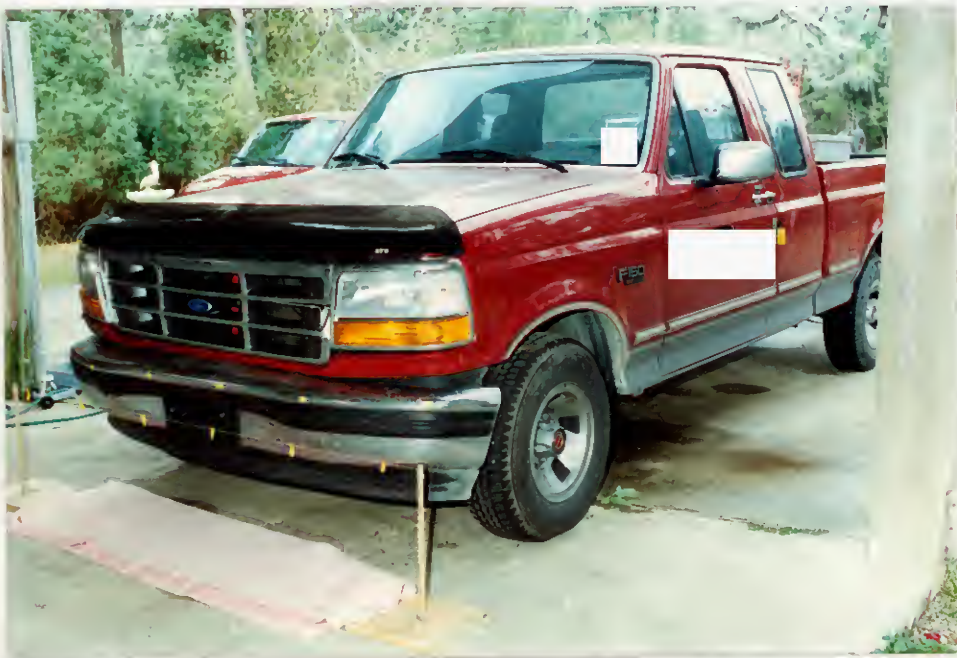
4. Left front three-quarter view.

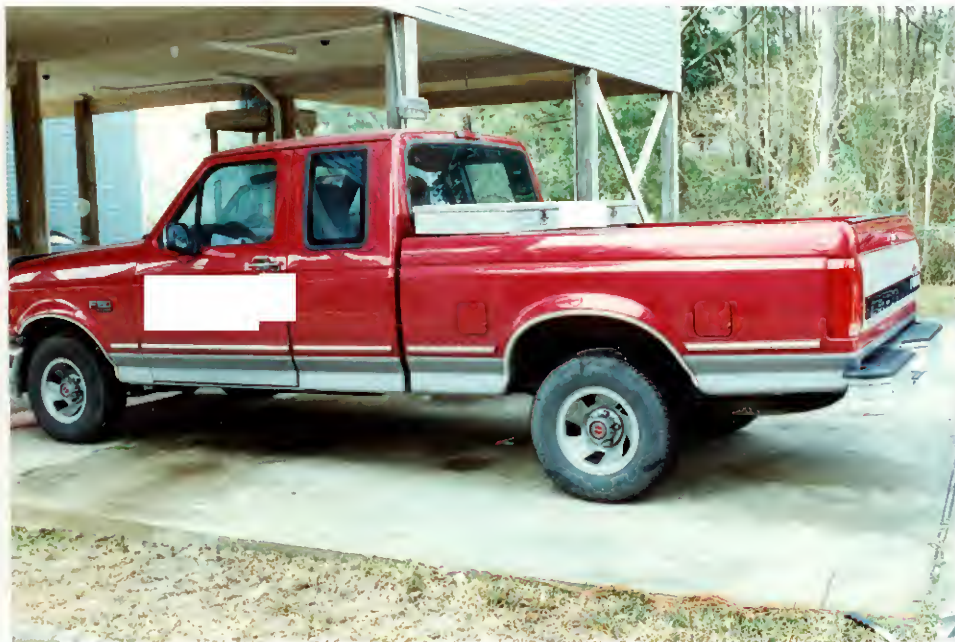
7. Left side view of the Ford F-150 pickup truck.

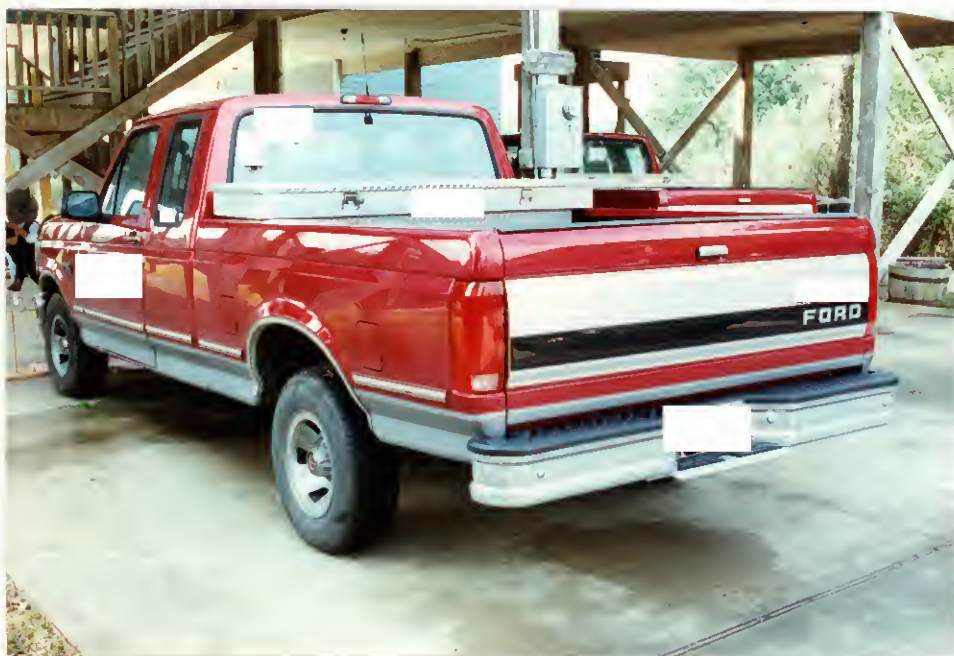
8. Left rear three-quarter view.

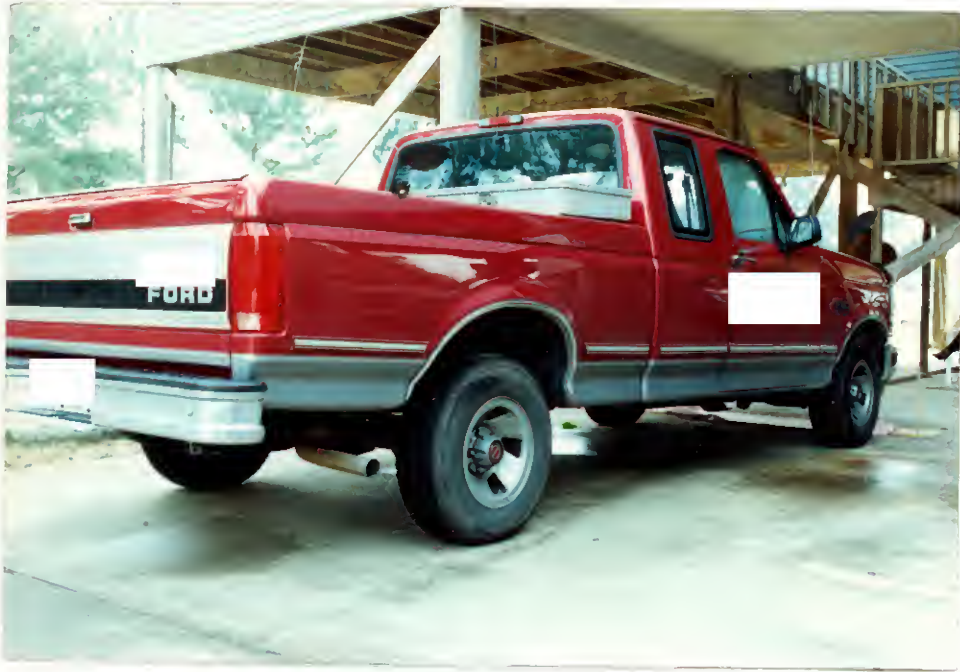
9. Right rear three-quarter view.

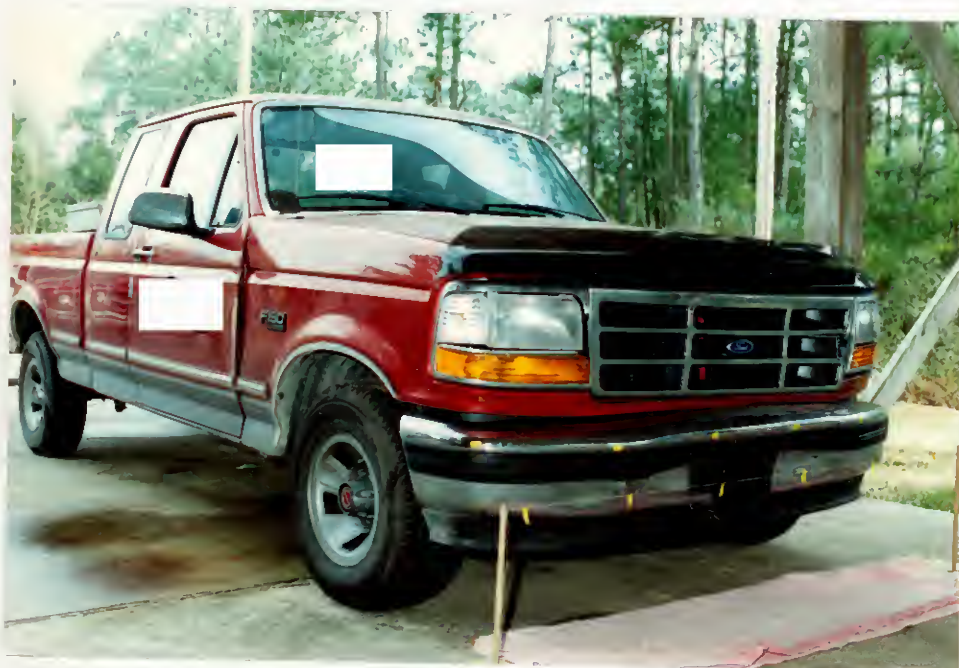
13. Right front three-quarter view.

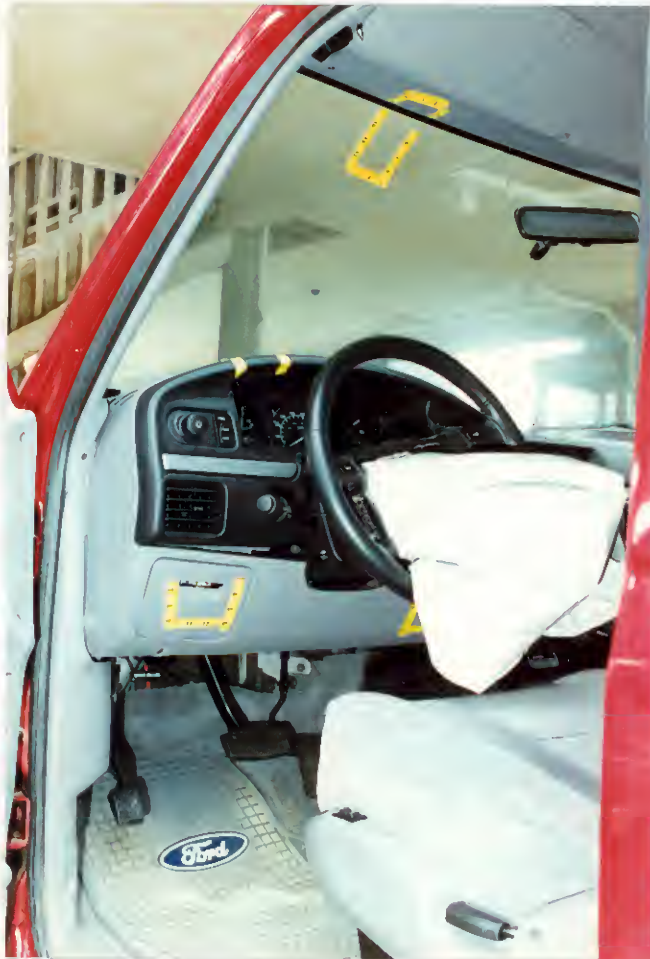
15. Overall view of the driver's trajectory and contact points.

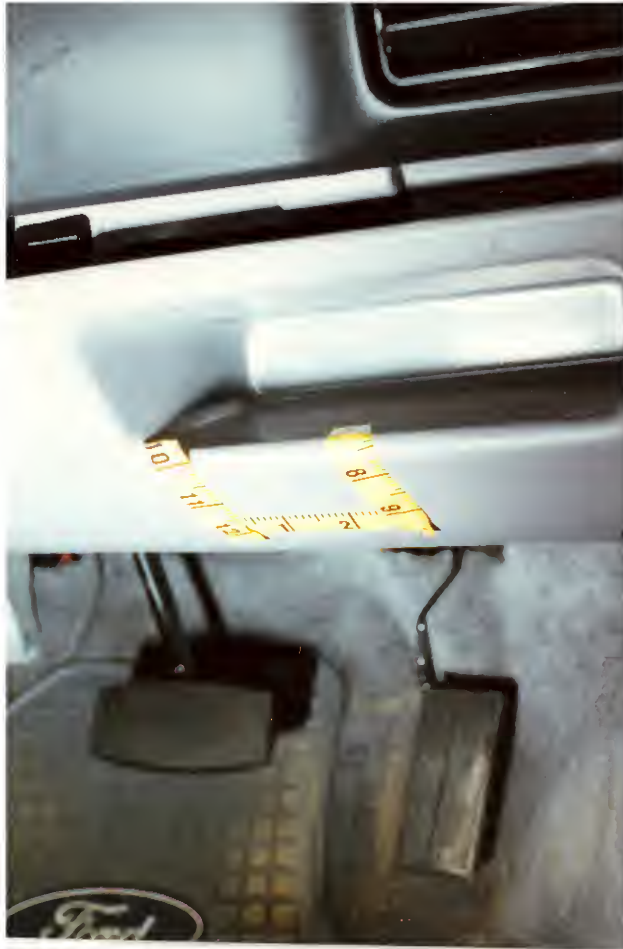
19. Right knee contact (scuff) to the bolster.

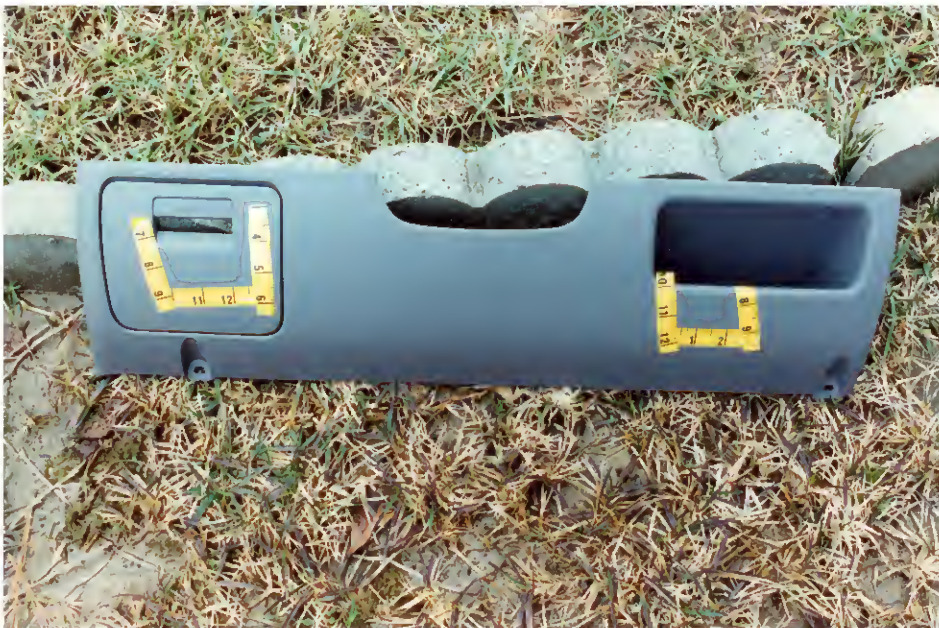
20. Bolster removed from vehicle.

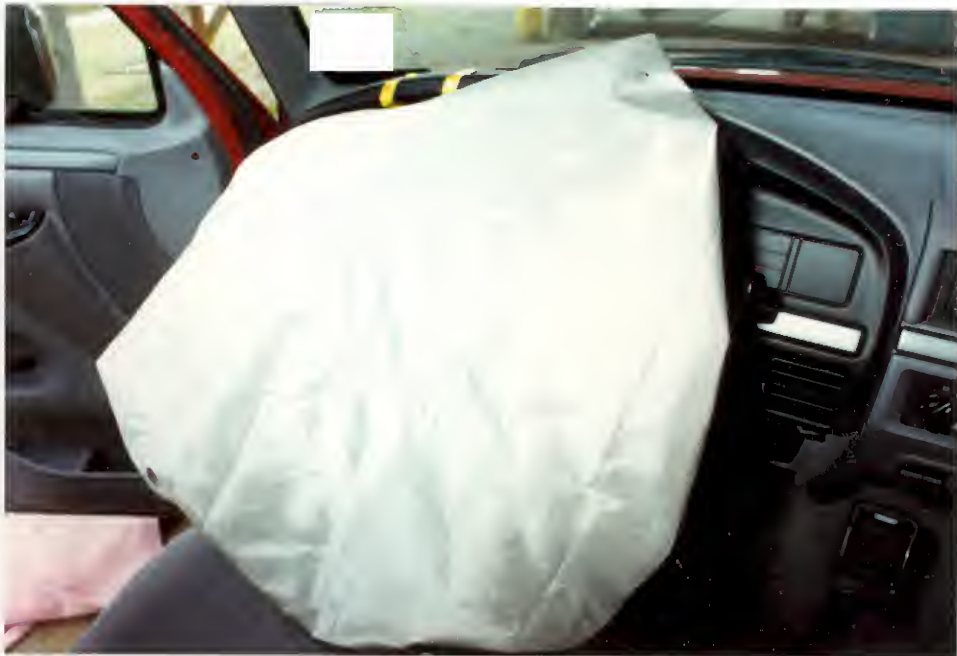
22. Deployed driver's side air bag.

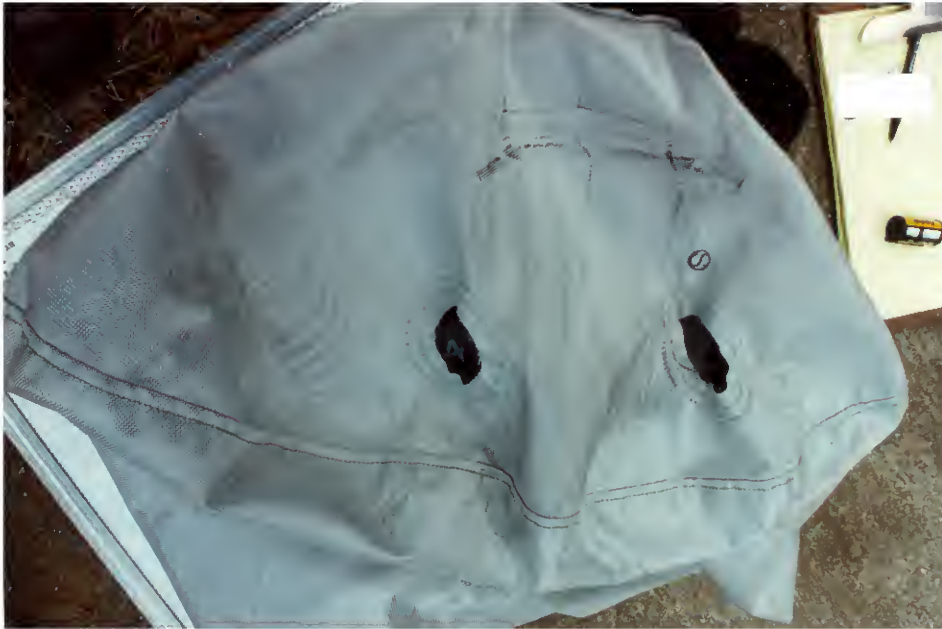
29. Upper flap vinyl transfers and vent ports.

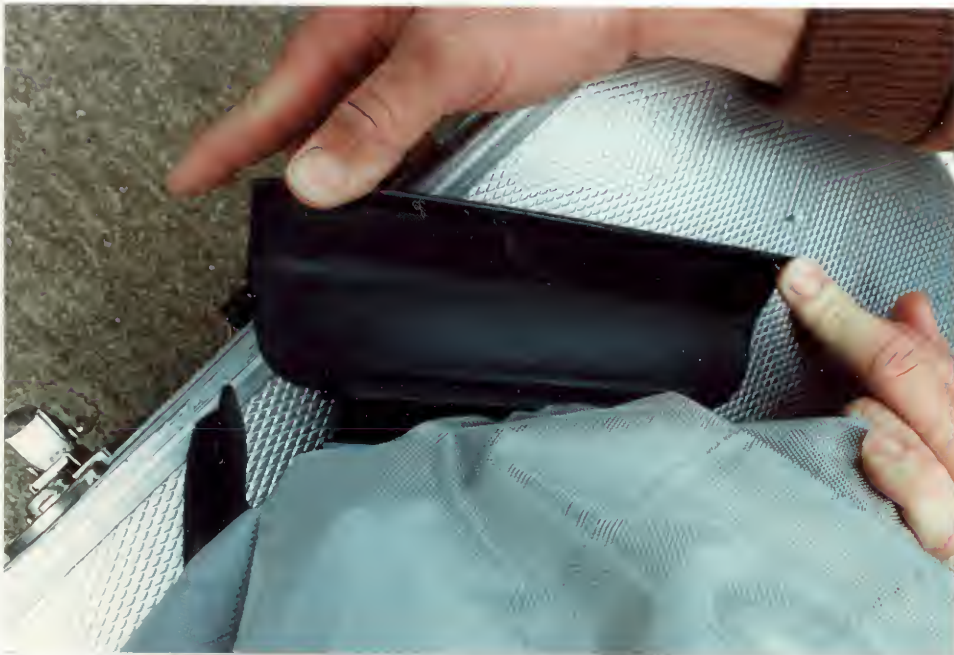
30. Air bag fabric transfers on the inner surface of the lower flap.

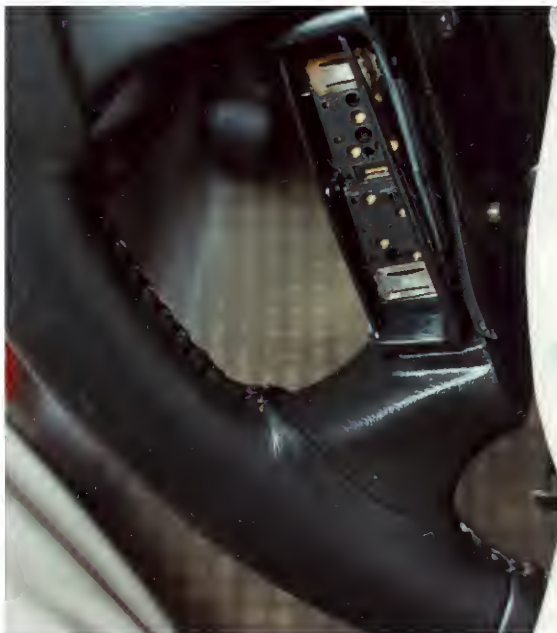
34. Displaced cruise control switches and fabric transfer on the left lower spoke.

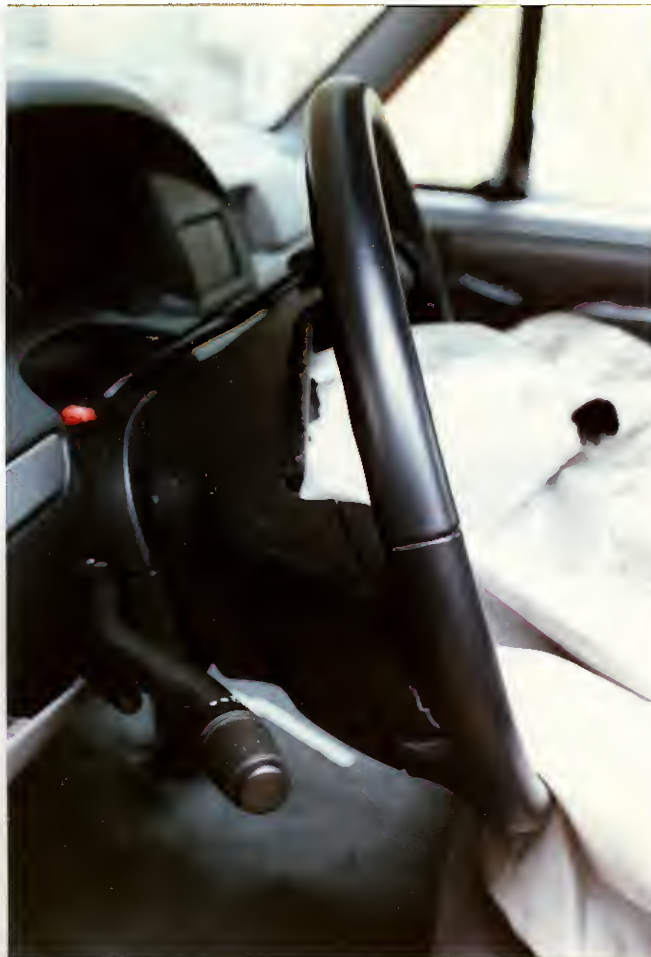
36. Perpendicular view of the steering wheel rim.

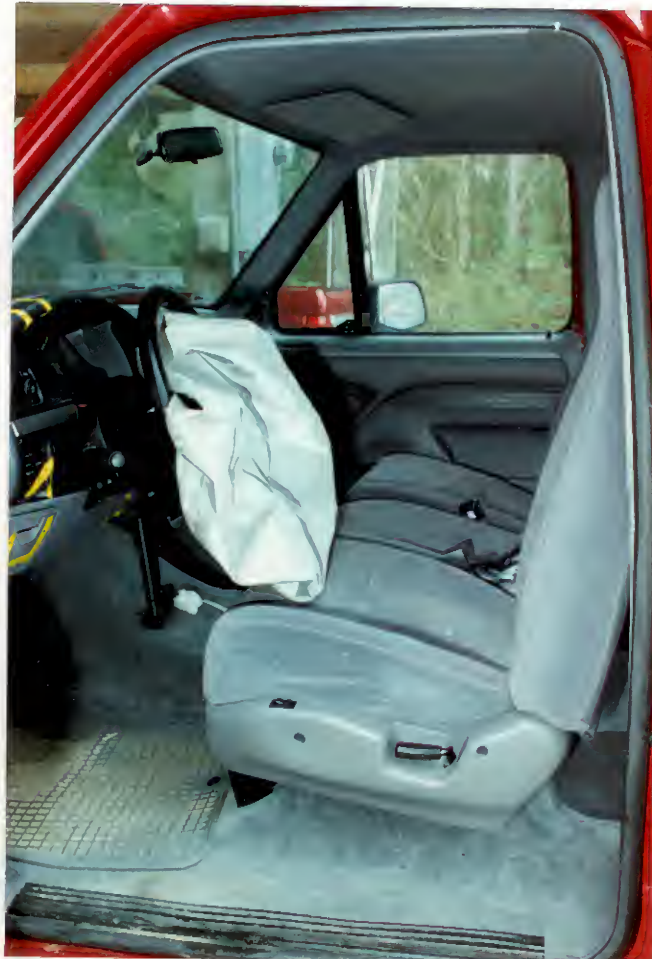
40. Driver's seat track adjustment with respect to the steering assembly.

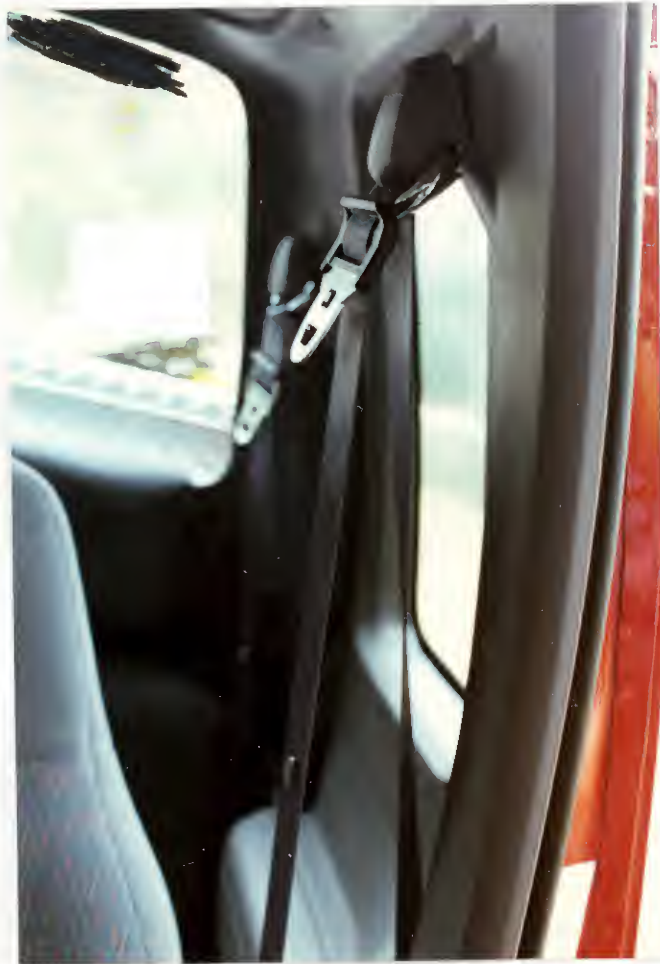
41. Stowed position of the driver's side manual 3-point lap and shoulder belt system.

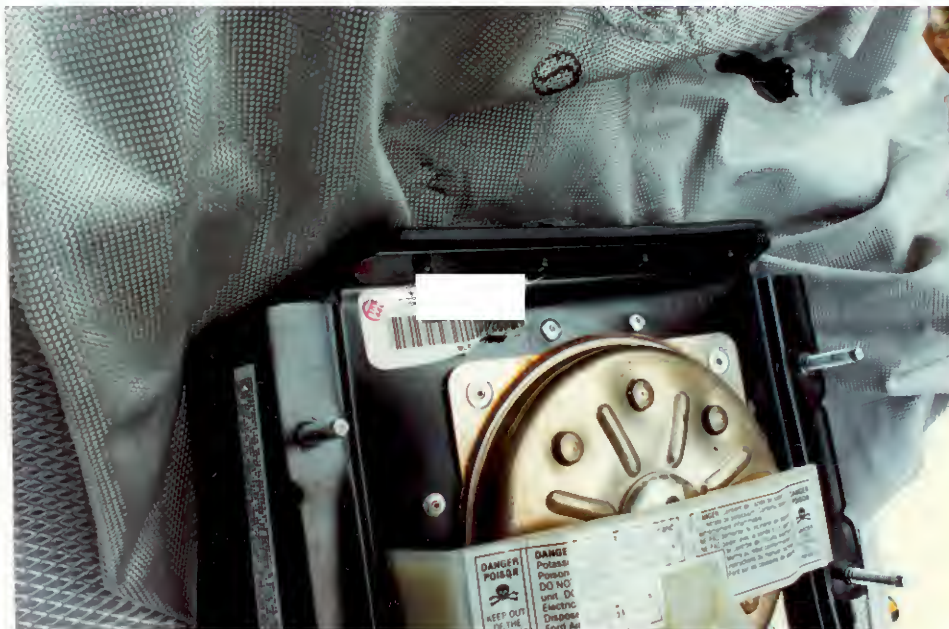
46. Close-up view of the bar-coded label at the top of the inflator assembly.

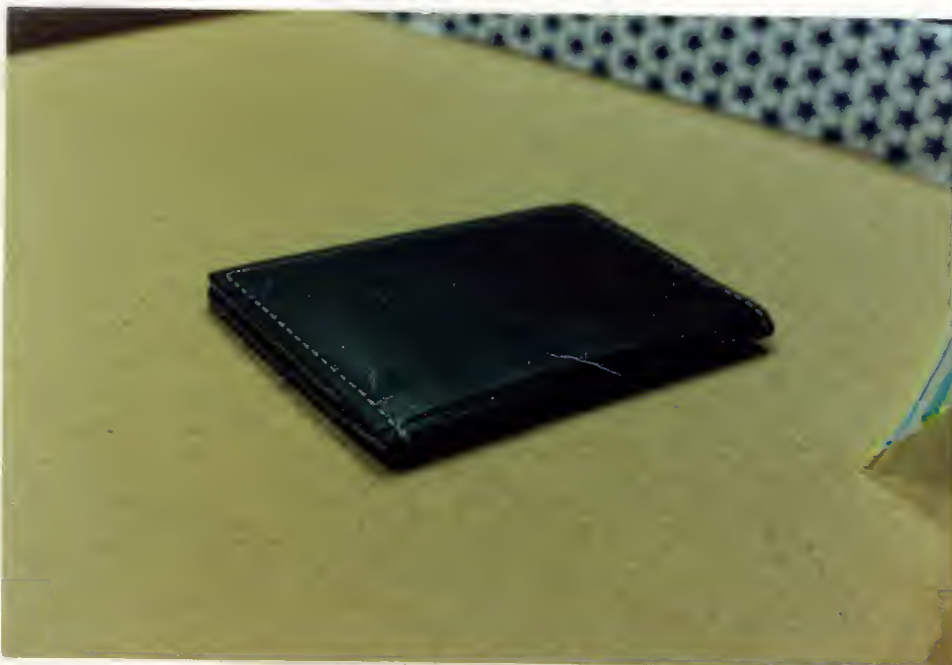
55. Additional view of the fabric transfer on the pocket calendar.
